No.: GGJ06.2020.MY34.02.4546

# Test Report

Product Name: Protection device for agricultural excavator

Product Type : 28

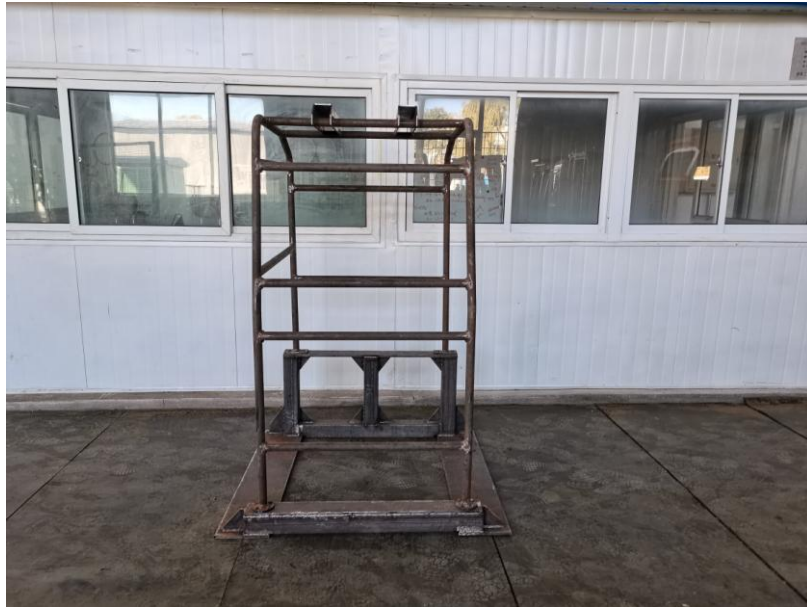
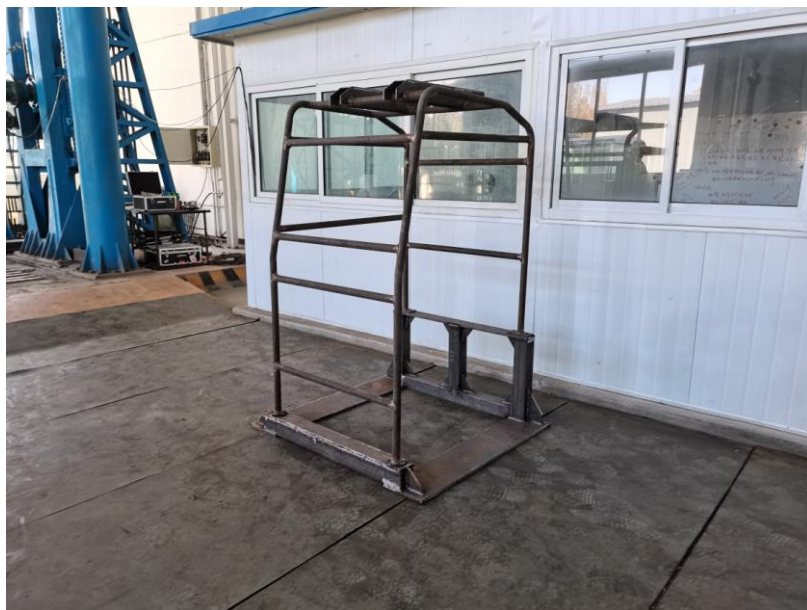
Figure A1 sample appearance

The TOPS is produced and designed by Shandong Rippa Machinery Group Co., Ltd.. It is suitable for the Shandong Rippa Machinery Group Co., Ltd. R328 Agricultural excavator. The sample is in a normal state before test.

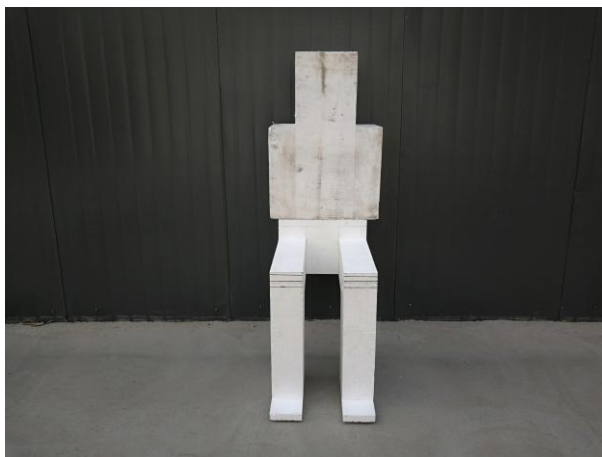
Figure D1 Deflection-limiting Volume

According to ISO 3164:2013,we have fixed DLV, see figure D1. The location of DLV in the TOPS, see figure D2.
