# CERTIFICATE

**Registration No.:** AK 50601655 0001  
**Report No.:** CN23WRCB 001  
**Holder:** SHANDONG RIPPA MACHINERY GROUP  
CO. , LTD.  
No. 6 Industrial Park,  
No. 2166 Chongwen Avenue, High tech Zone  
272000 Jining City, Shandong Province  
P.R. China  
**Product:** Excavator  
(Hydraulic Excavator)

| <b>Prüfbericht-Nr.:</b><br>Test Report No.: | <b>CN23WRCB 001</b> | <b>Auftrags-Nr.:</b><br>Order No.: | <b>178187350</b> | <b>Seite 1 von 36</b><br>Page 1 of 36 |
| <b>Prüfgegenstand:</b><br>Test item: | <b>Hydraulic Excavator</b> | | | |

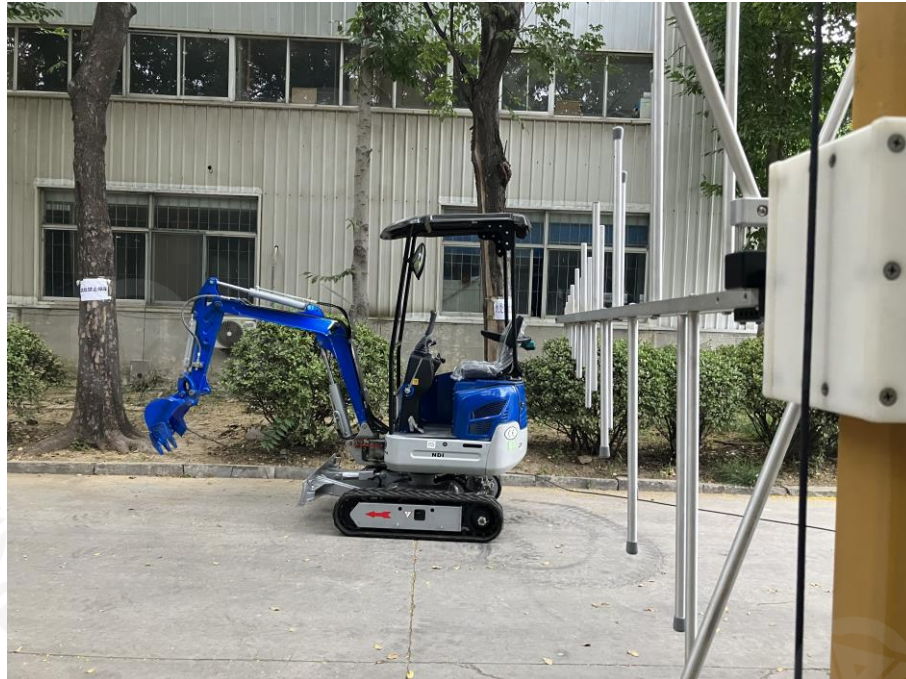
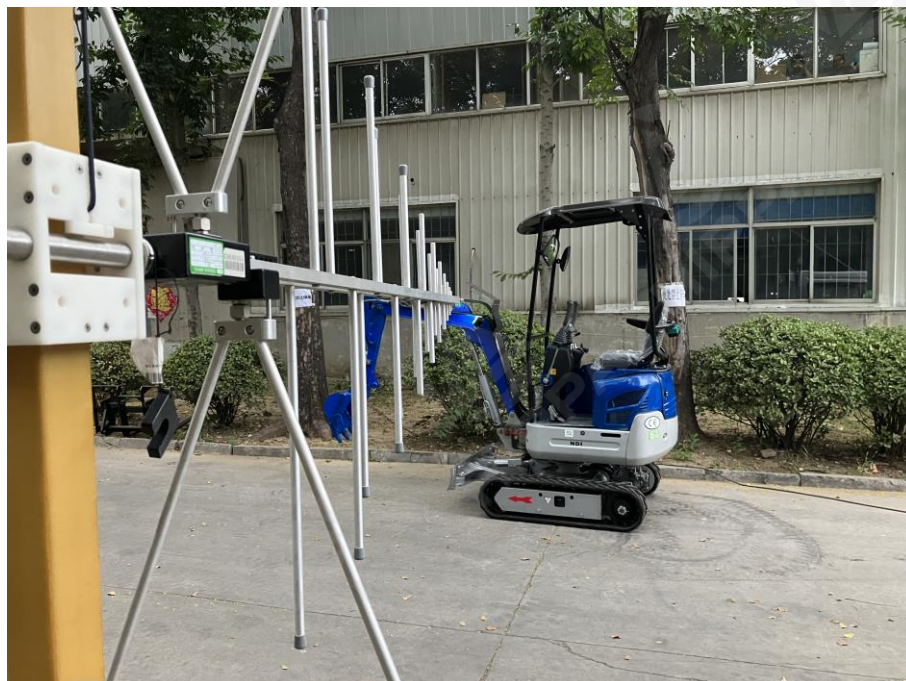
**Photograph 1: Set-up for radiated electromagnetic disturbances above 30MHz**

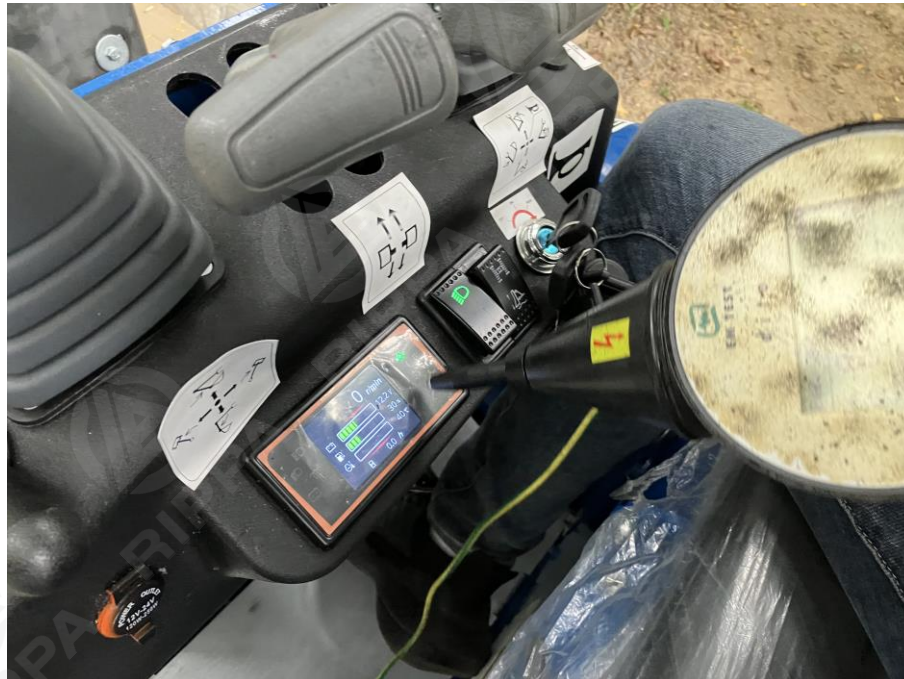
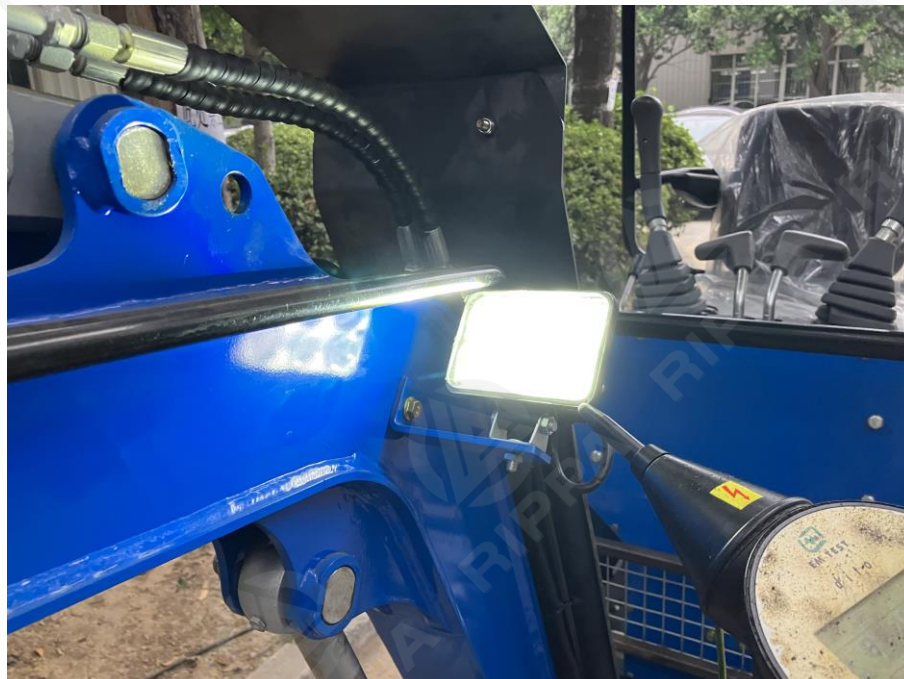
**Photograph 2: Set-up for immunity test of ESD**

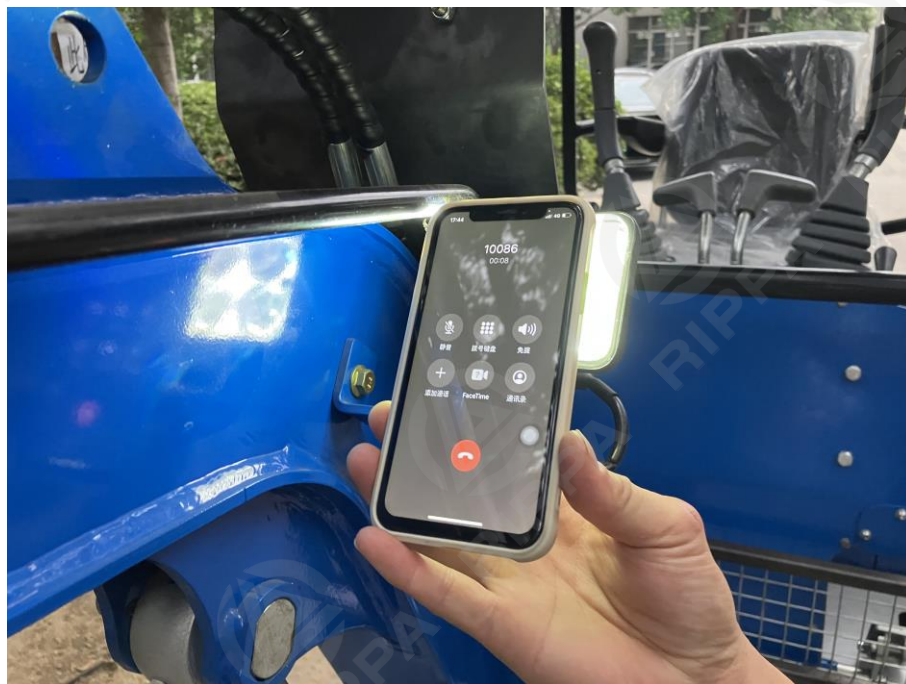
**Photograph 3: Set-up for radio frequency electromagnetic field**
