# CERTIFICATE

**Registration No.:** AK 50601651 0001  
**Report No.:** CN238P5I 001  
**Holder:** SHANDONG RIPPA MACHINERY GROUP  
CO. , LTD.  
No. 6 Industrial Park,  
No. 2166 Chongwen Avenue, High tech Zone  
272000 Jining City, Shandong Province  
P.R. China  
**Product:** Loader  
(Skid Steer Loader)

| <b>Prüfbericht-Nr.:</b><br>Test Report No.: | <b>CN238P5I 001</b> | <b>Auftrags-Nr.:</b><br>Order No.: | <b>178187350</b> | <b>Seite 1 von 28</b><br>Page 1 of 28 |
| <b>Prüfgegenstand:</b><br>Test item: | <b>Skid Steer Loader</b> | | | |

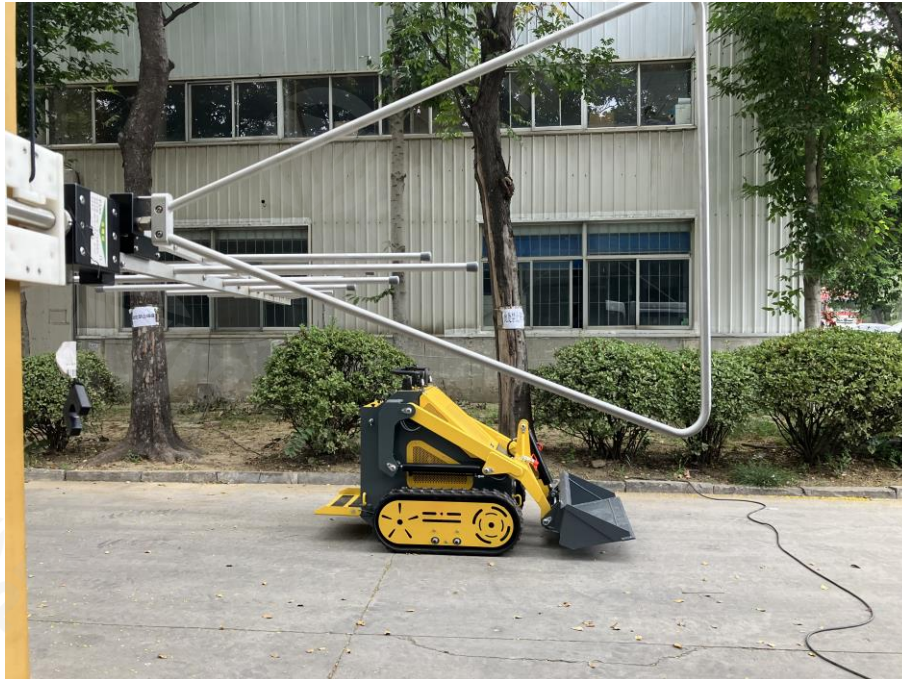
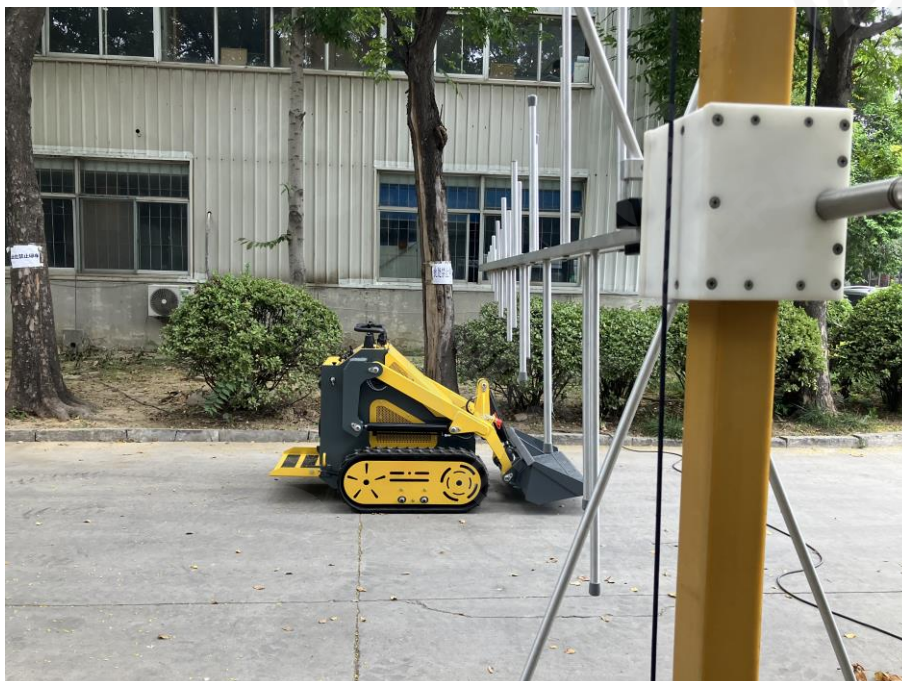
**Photograph 1: Set-up for radiated electromagnetic disturbances above 30MHz**

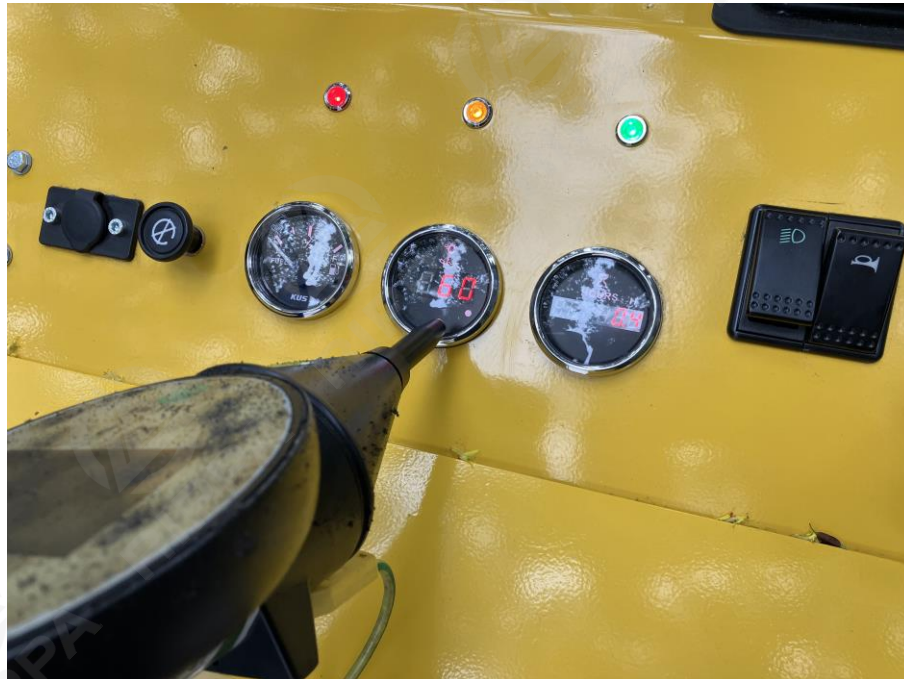
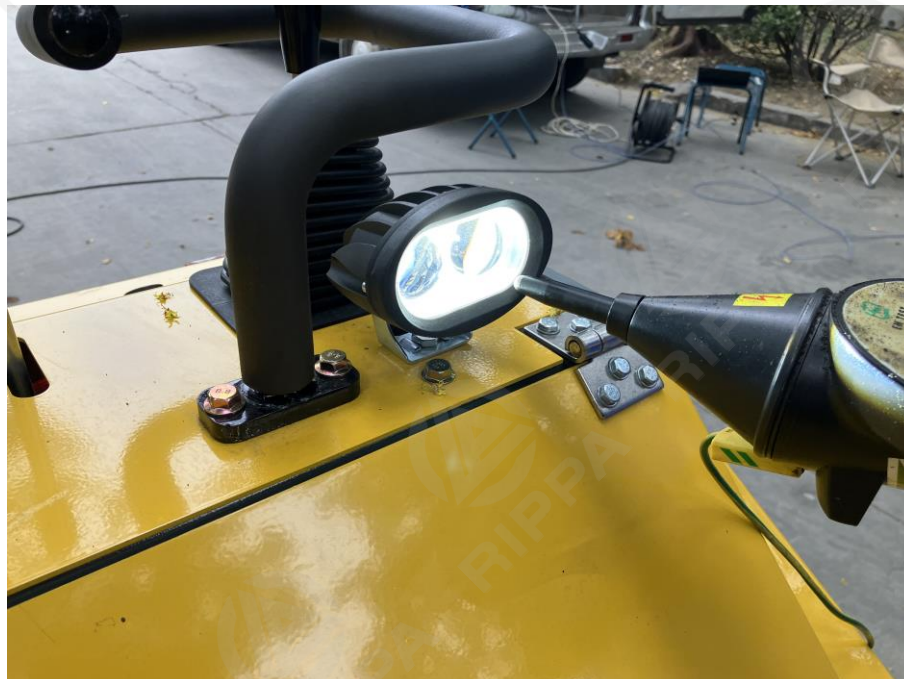
**Photograph 2: Set-up for immunity test of ESD**

The immunity against electrostatic discharge was tested in accordance with EN ISO 13766-1:2018. Test setup and ESD-Generator are according to ISO 10605:2008 which is specified by EN ISO 13766-1:2018.

Charge voltage :  $\pm 4.0\text{kV}$ ,  $\pm 6.0\text{kV}$  (Contact Discharge)  
 $\pm 4.0\text{kV}$ ,  $\pm 8.0\text{kV}$  (Air Discharge)  
 Generator capacitance : 330 pF (inside of the machinery)  
 150 pF (outside of the machinery)  
 Polarity : positive / negative  
 Number of discharges : >10 at each point  
 Operation mode : Engine and all electronic systems on  
 Performance criteria : Class A( $\pm 4.0\text{kV}$  Contact and Air discharge)  
 Class C( $\pm 6.0\text{kV}$  Contact discharge and  $\pm 8.0\text{kV}$  Air discharge)

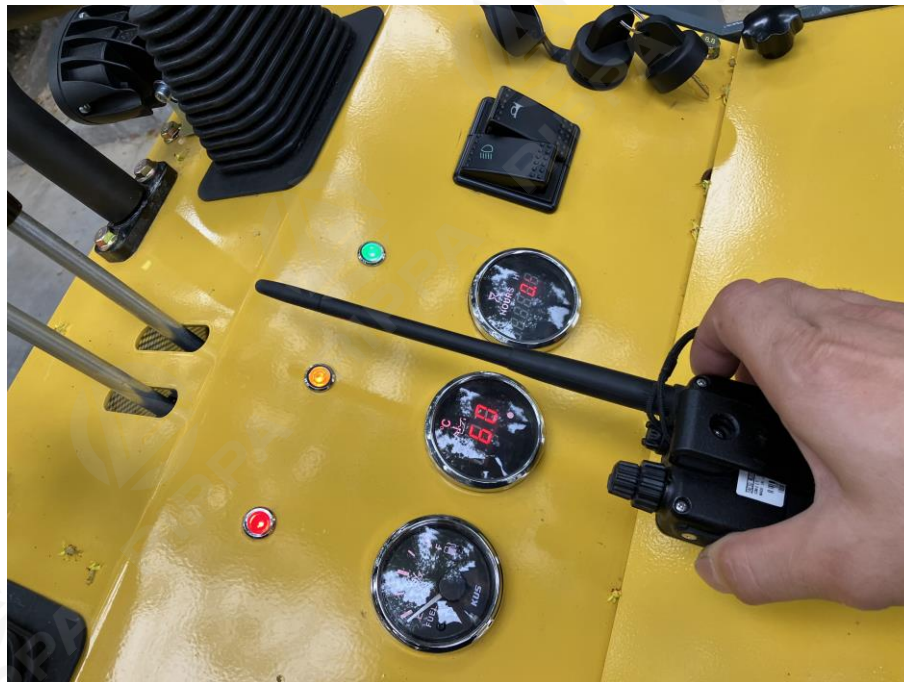
**Photograph 3: Set-up for radio frequency electromagnetic field**

According to clause A.3.2.2 of IEC 61800-3:2004+A1, the test was only performed at some discrete frequencies.

| Test level | : 30V/m |
| Test frequencies | : 52MHz: ISM frequency<br>145MHz: business radio band<br>435MHz: ISM frequency<br>915MHz: GSM915 |
