## TEST SUMMARY

The EUT (equipment under test) is a skid steer loader. For the further information, refer to the user's manual.

**Prüfbericht - Nr.: CN238P5I 001**

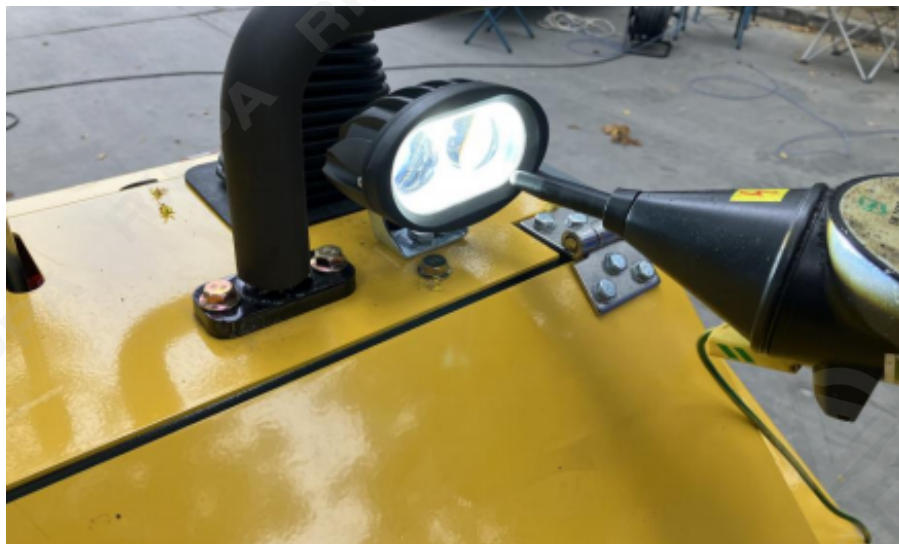
**Photograph 2: Set-up for immunity test of ESD**
